AIR MONITORING REPORT

**Location: Erne Palais Ballroom,
Holborn Hill, Belturbet, Co. Cavan**

Date of Tests: 25th September 2018

Report No. PE18-756

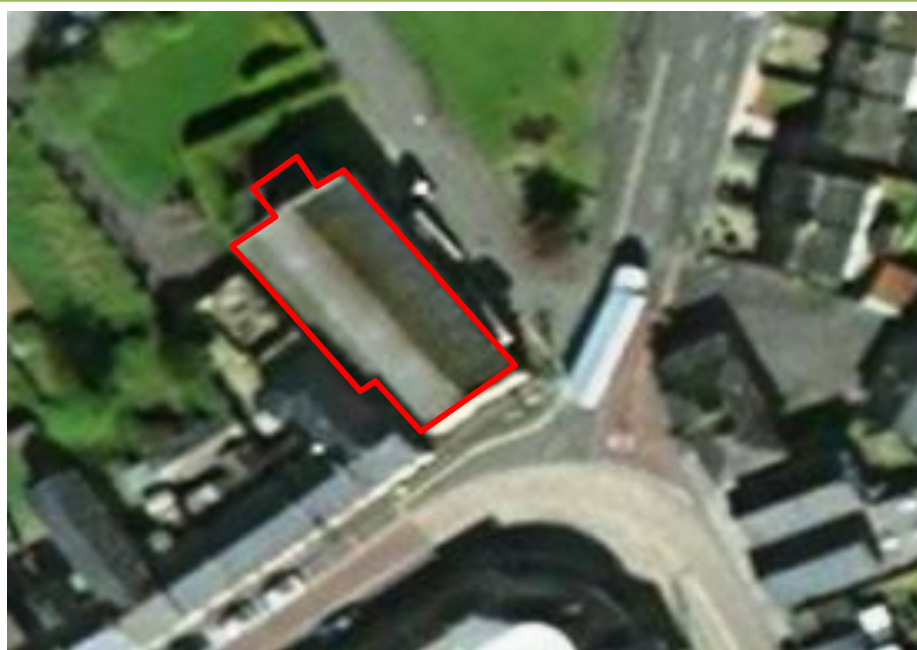
Location of fire damaged Erne Palais Ballroom

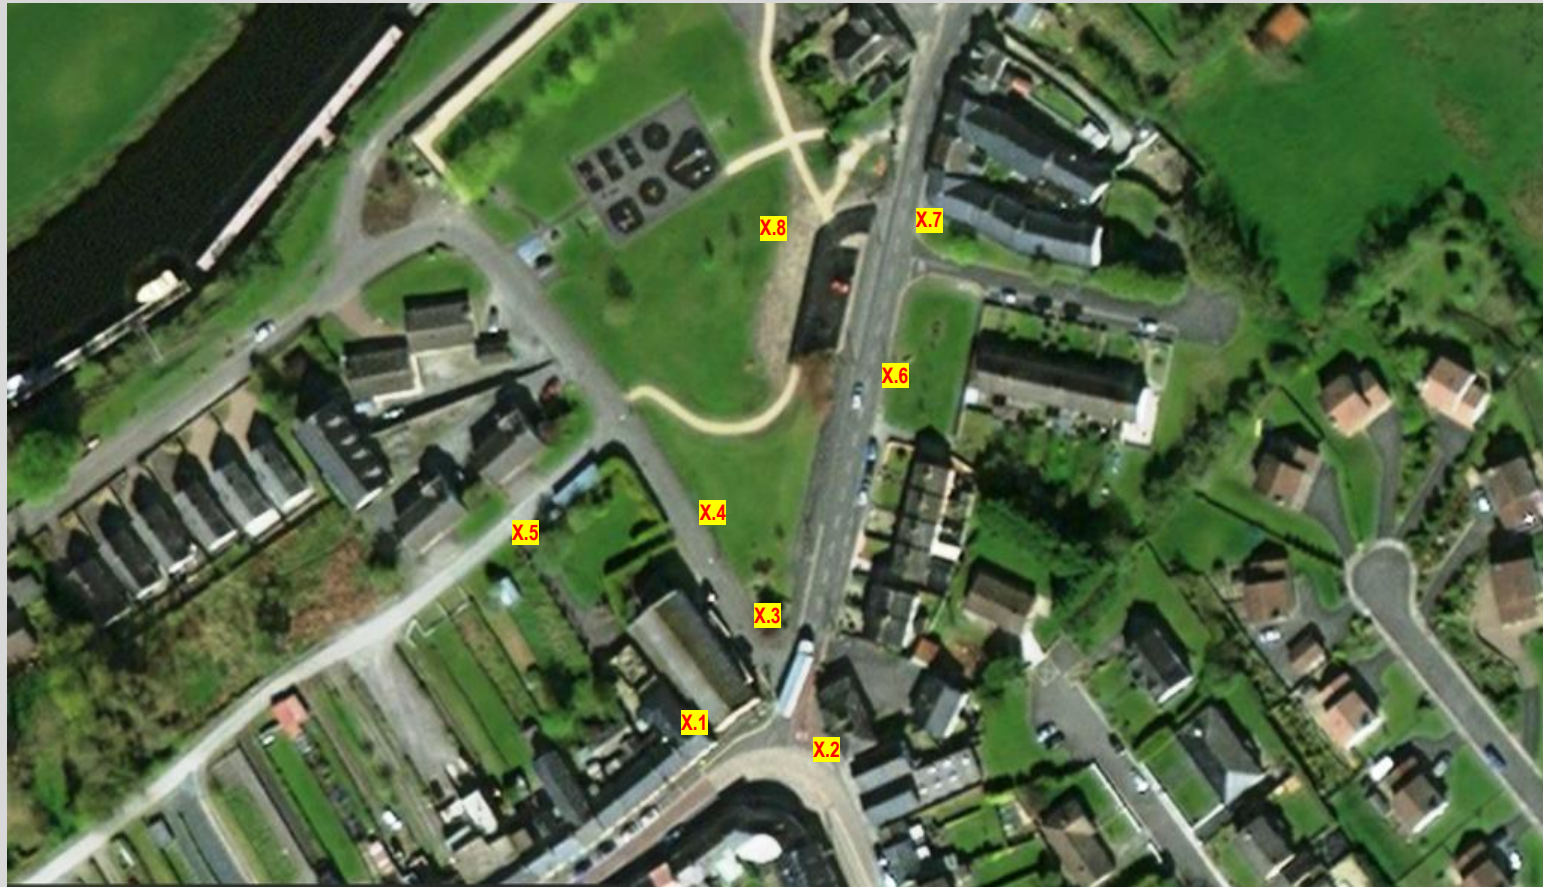
AIR MONITORING LOCATIONS: X DATE: 25th SEPTEMBER 2018. WEATHER CONDITIONS: DRY & CLOUDY. 12°. SSW WIND 17 KM/H. GUSTS OF 22 KM/H
