Site Inspection Report

Alan Traynor
Consulting Engineers Ltd.

Project Name:
23.322 - Teresa Weeks Cavan Co Co

Description
Structural Survey of existing buildings

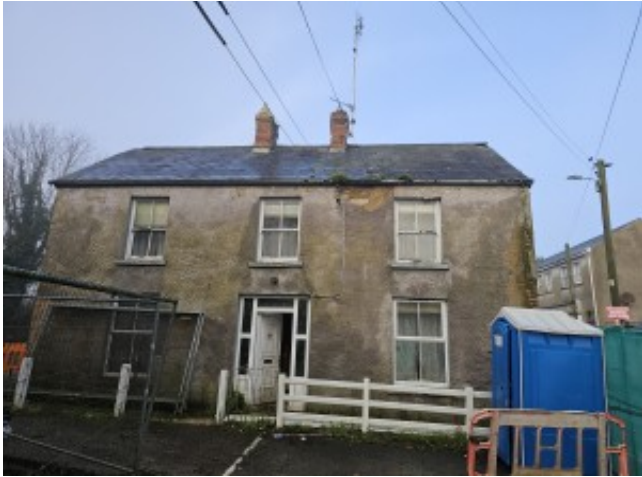
001 / 001

Comment
Front elevation of property and power cables to be disconnected prior to demolition

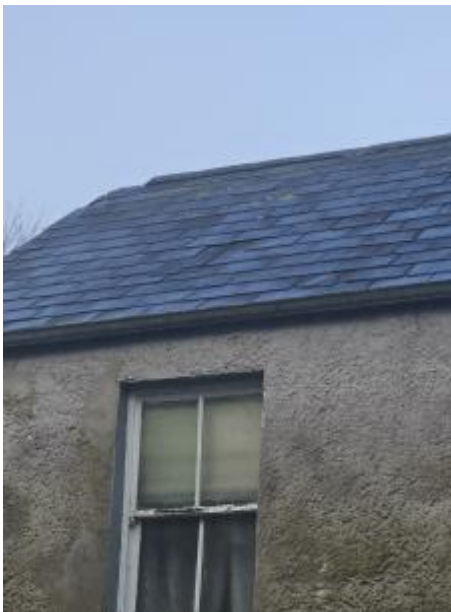
001 / 002

Comment
Front elevation with slipped natural slates

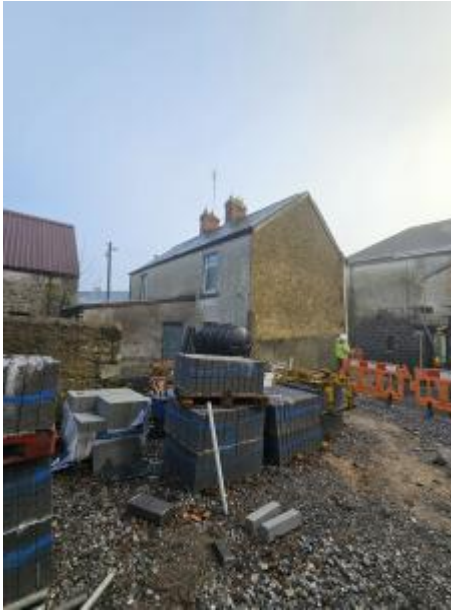
001 / 003

View of gable from rear of property

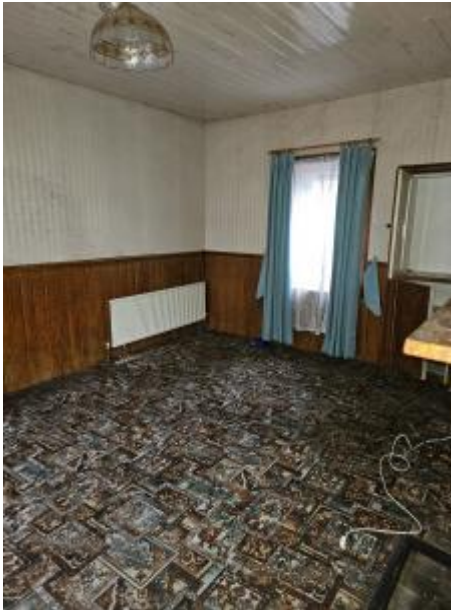
001 / 004

Front ground floor sitting room with suspended
timber floor with rotten timbers

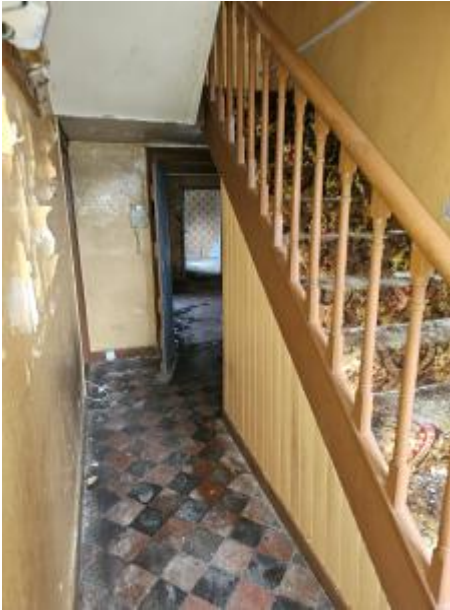
001 / 005

staircase to first floor

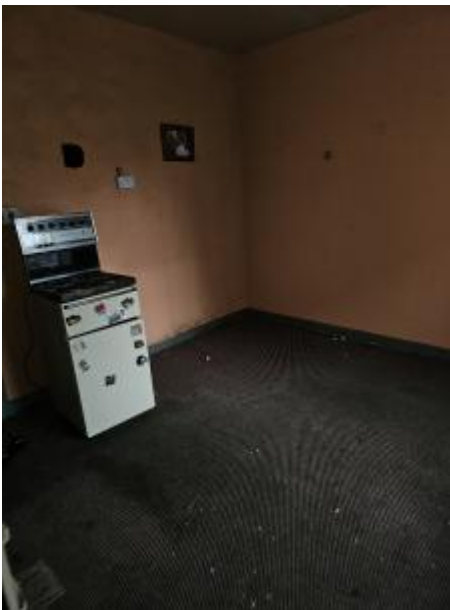
001 / 006

Ground floor kitchen

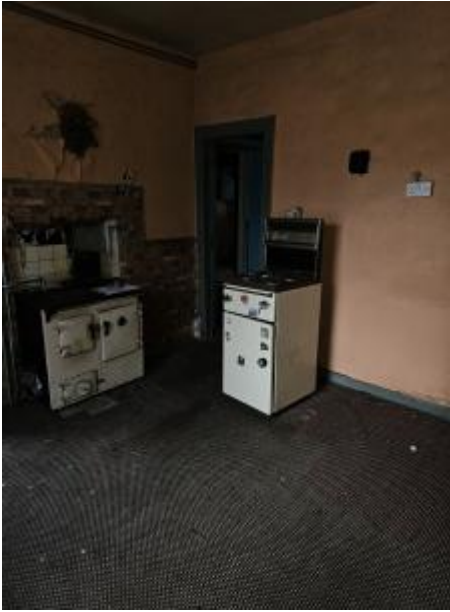
001 / 007

Ground floor kitchen

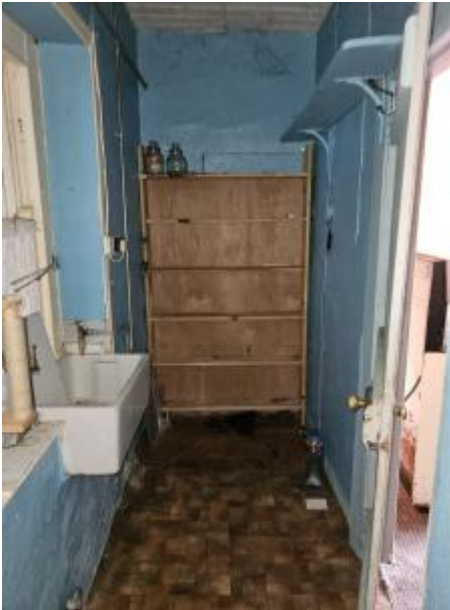
001 / 008

Ground floor utility

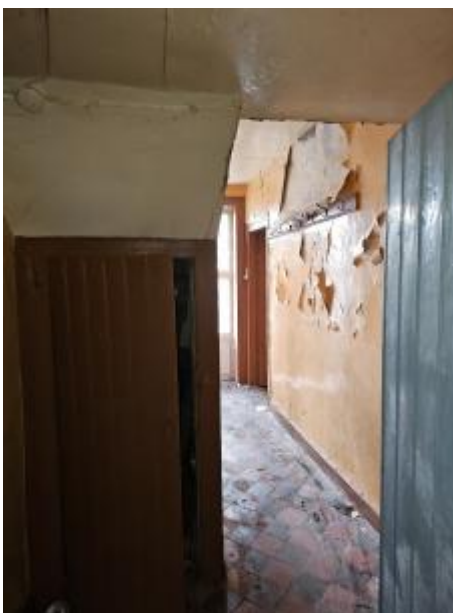
001 / 009

Hallway under the stairs

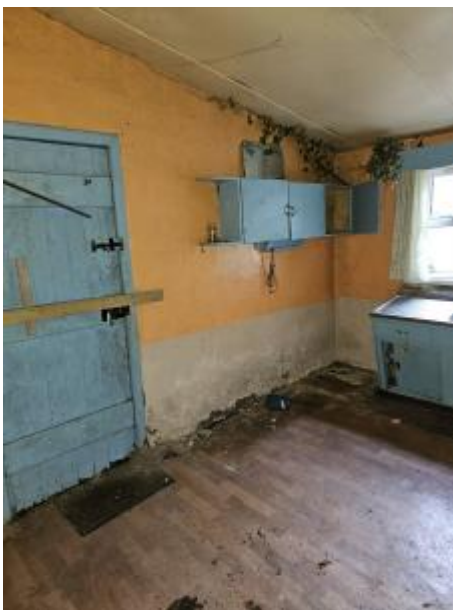
001 / 010

Ground floor kitchen extension

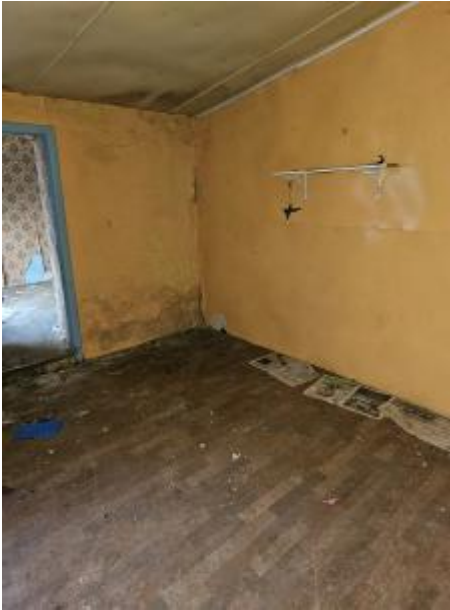
001 / 011

Rear extension

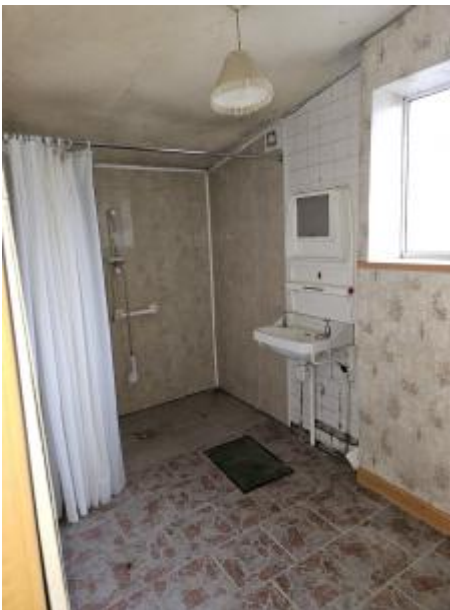
001 / 012

Converted room into disability bathroom

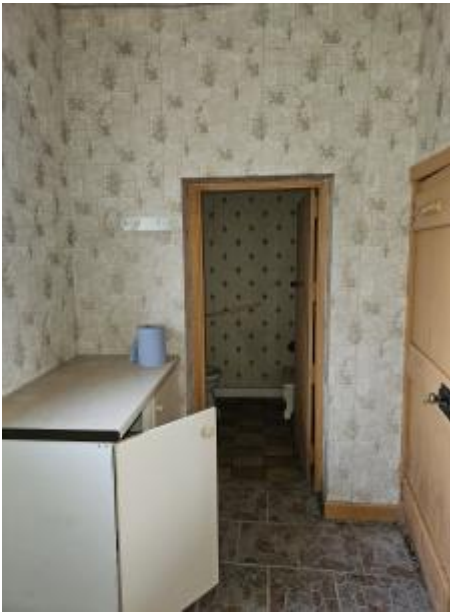
001 / 013

Downstairs toilet

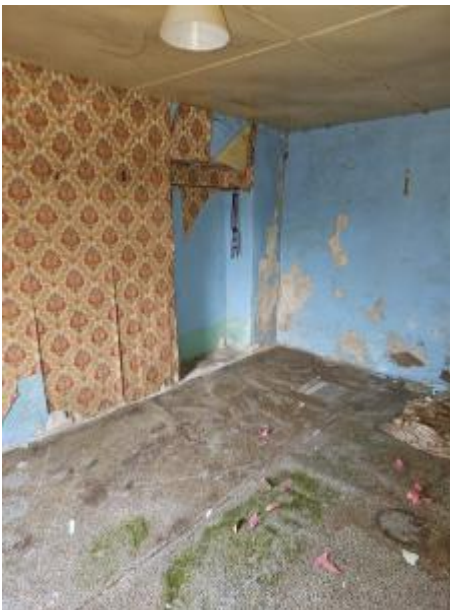
001 / 014

Part of main property that extends into the rear property

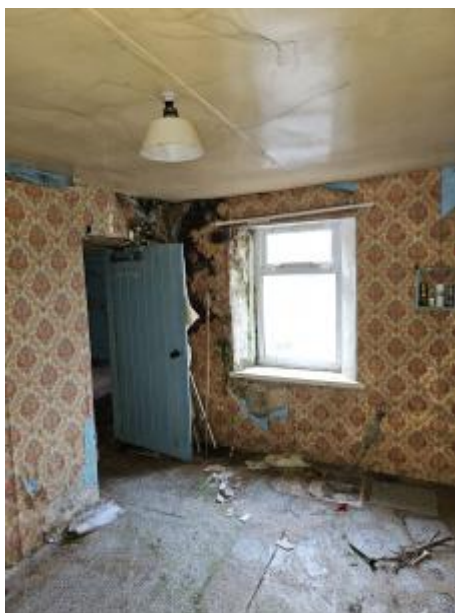
001 / 015

Rear downstairs extension where dampness is very evident

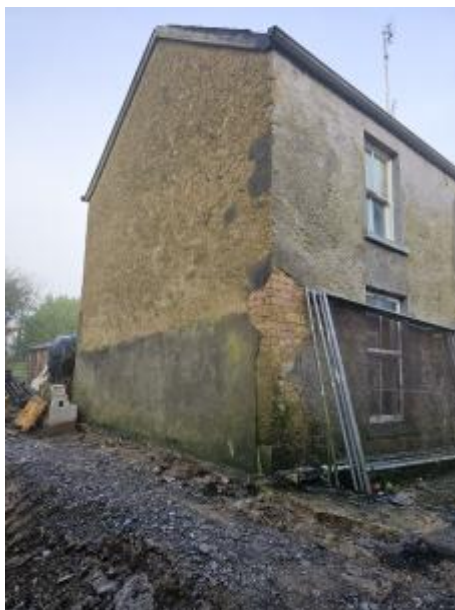
001 / 016

Gable with plaster partly removed to show brick quoins and stonework main structure

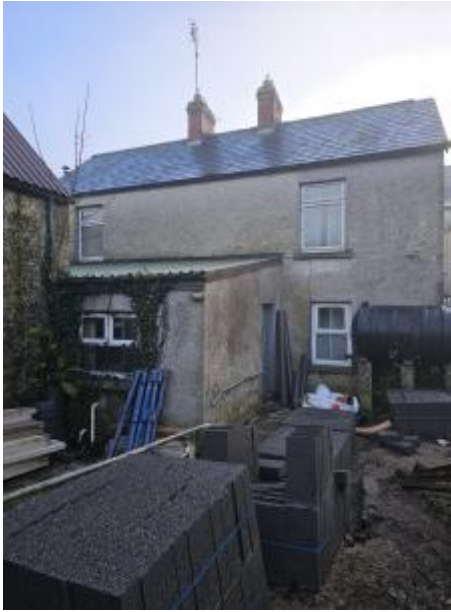
001 / 017

Rear elevation of building

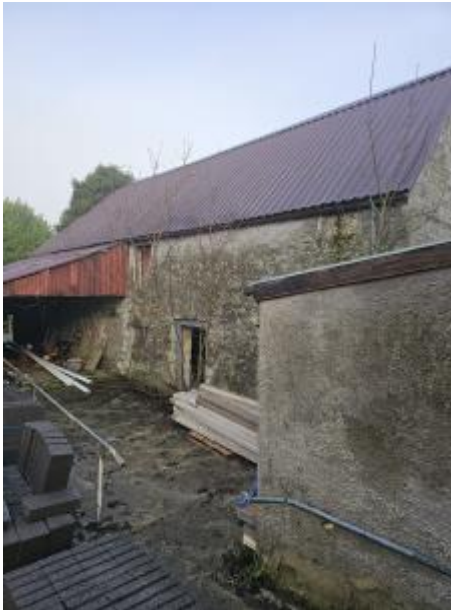
001 / 018

lean too roofed shed to rear property

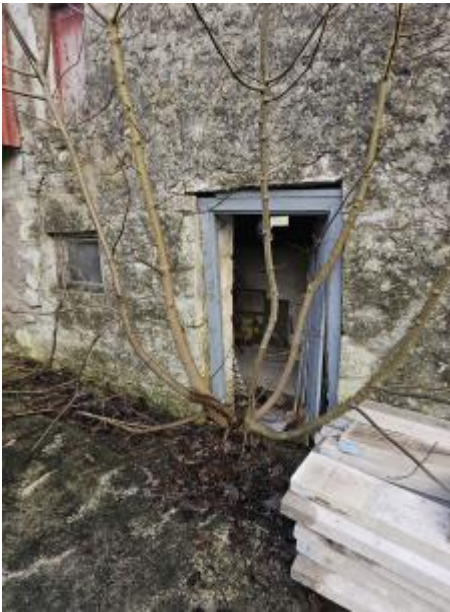
001 / 019

Old attached property to rear derelict

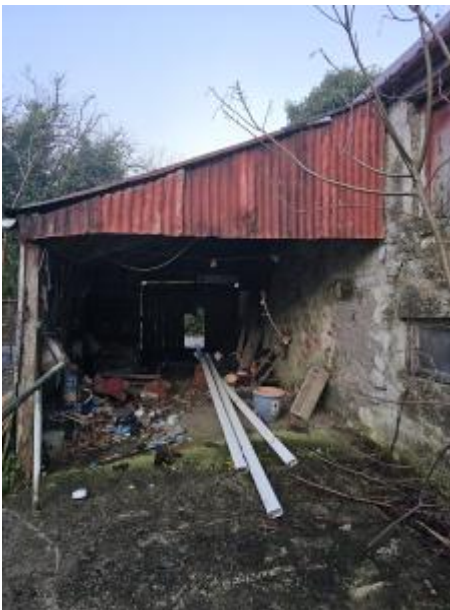
001 / 020

Lean too shed to be demolished

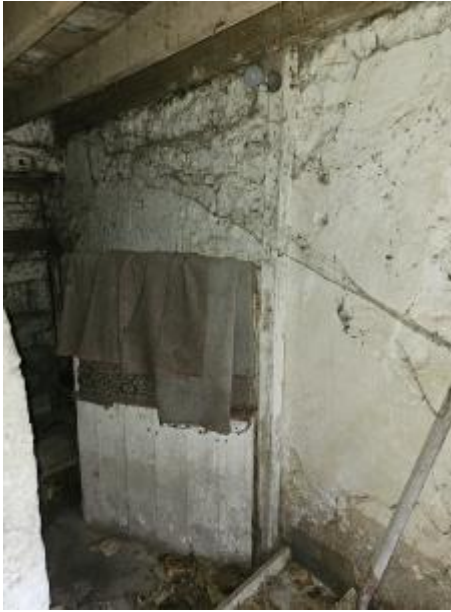
001 / 021

Internal walls to rear building

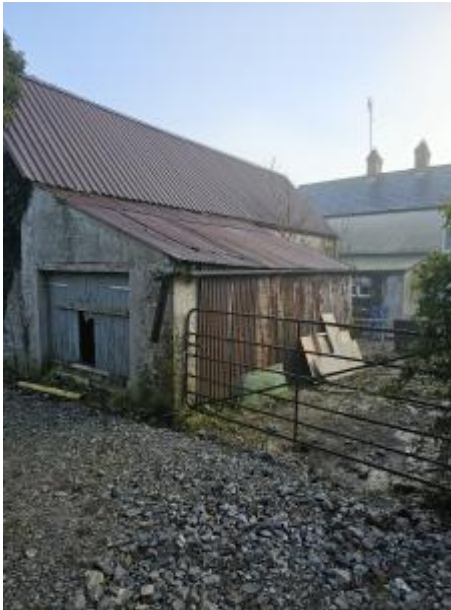
001 / 022

lean too roofed shed to rear property

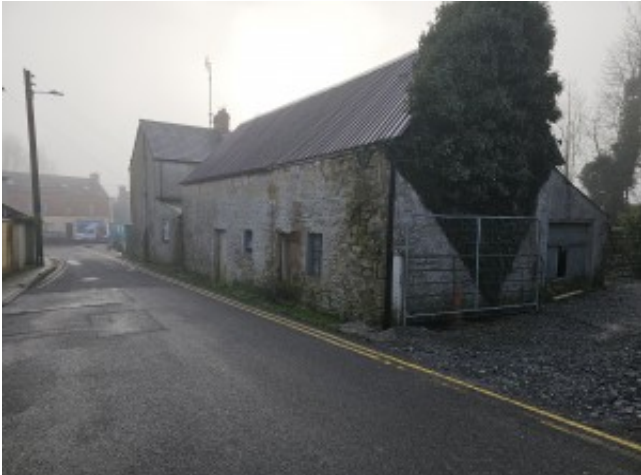
001 / 023

View down Preaching House Lane where access is to be widened to 6m

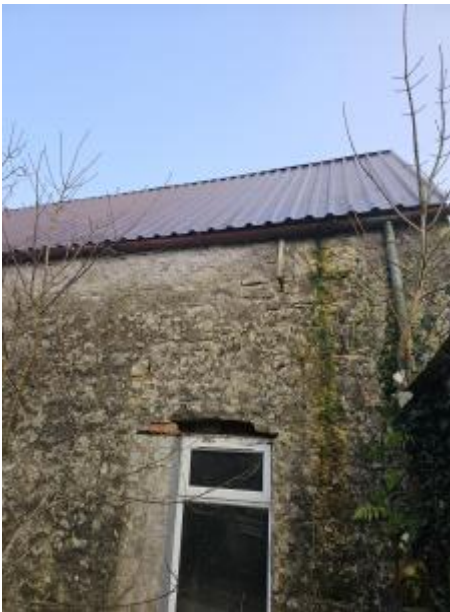
001 / 024

Corrugated single skin sheet to rear shed

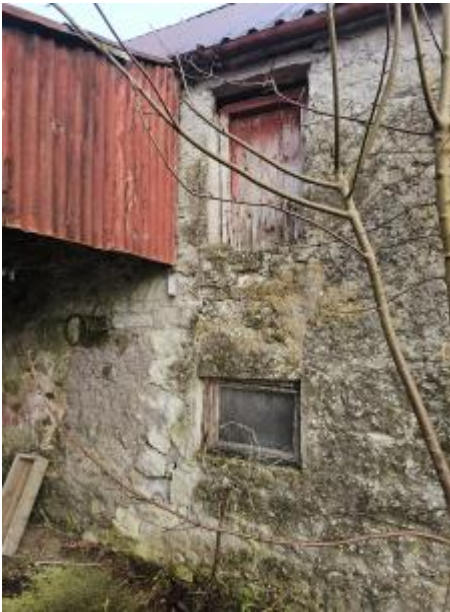
001 / 025

Rear metal sheeted roof

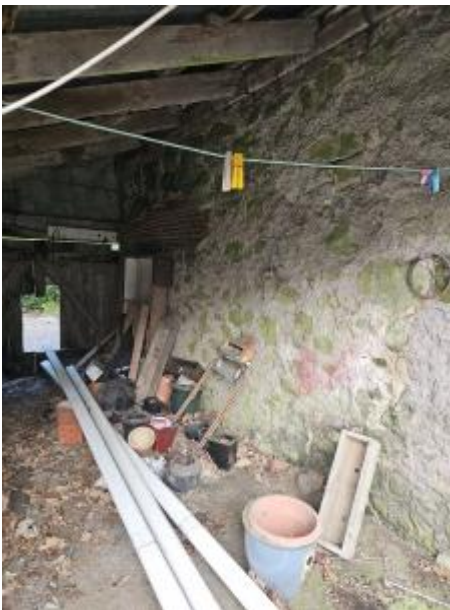
001 / 026

Lean too shed to be demolished

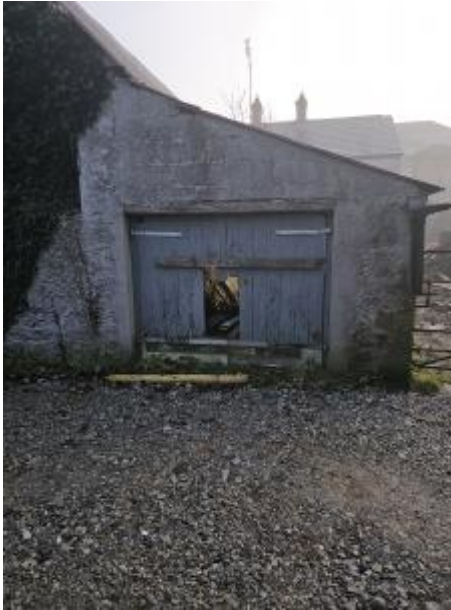
001 / 027

Rear door to lean too shed

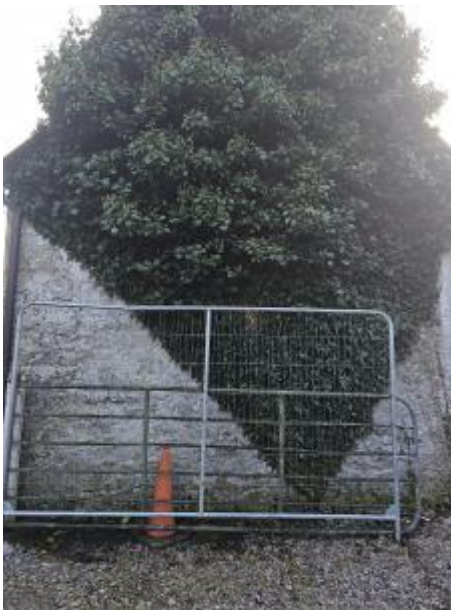
001 / 028

End gable of attached rear property

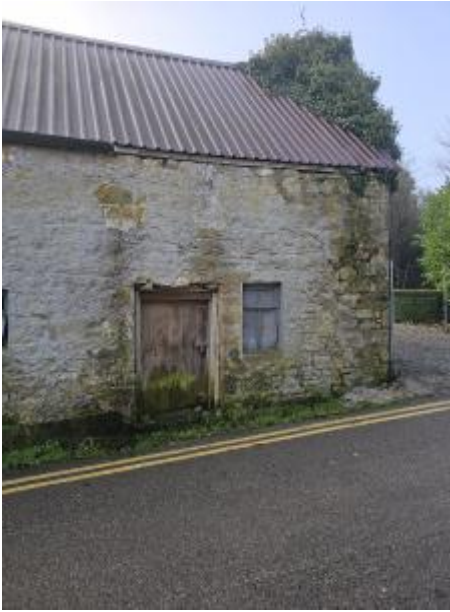
001 / 029

Gable of Building along Preaching House Lane to be demolished.

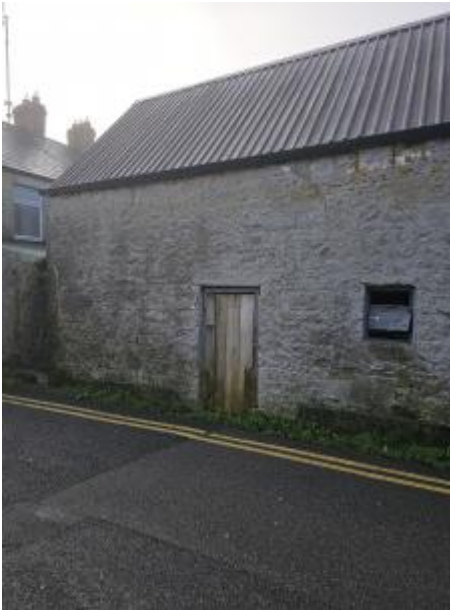
001 / 030

Building along Preaching House Lane to be demolished.

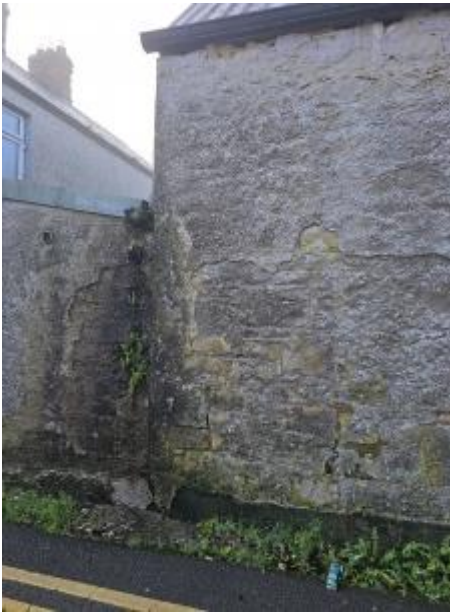
001 / 031

Gable of Building along Preaching House Lane to be demolished.

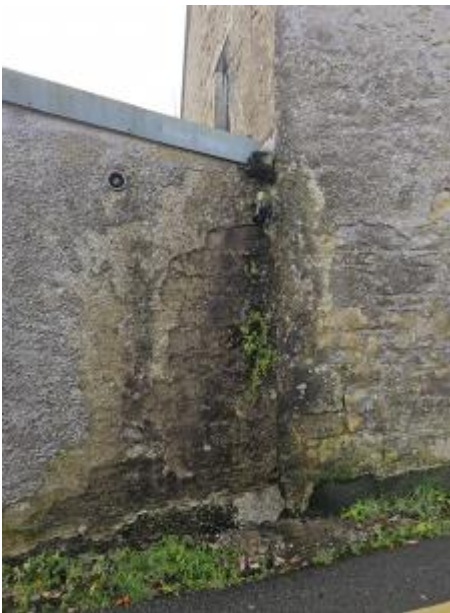
001 / 032

Gable of Building along Preaching House Lane to be demolished.

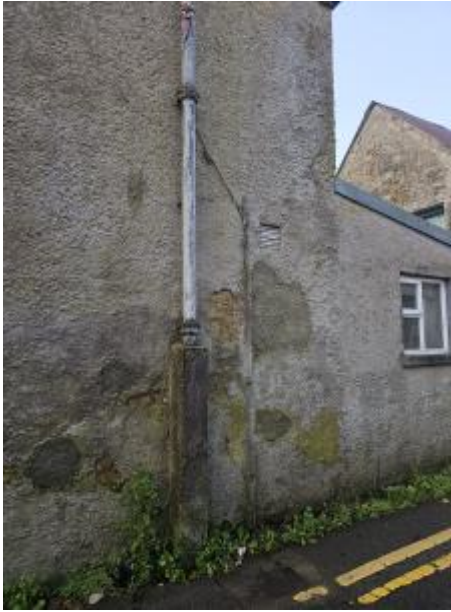
001 / 033

Comment
Gable of Building along Preaching House Lane to be demolished.

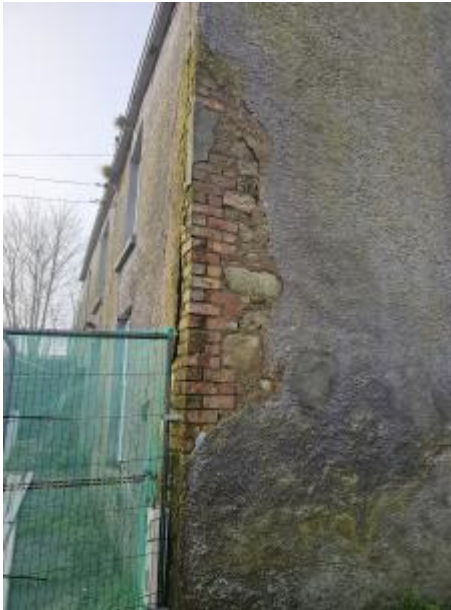
001 / 034

Comment
Brick and stone construction with plaster coming away from the stonework

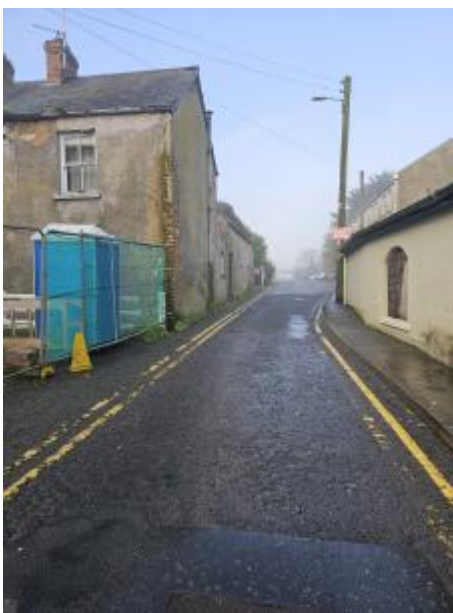
001 / 035

View up Preaching House Lane where access is to be widened to 6m

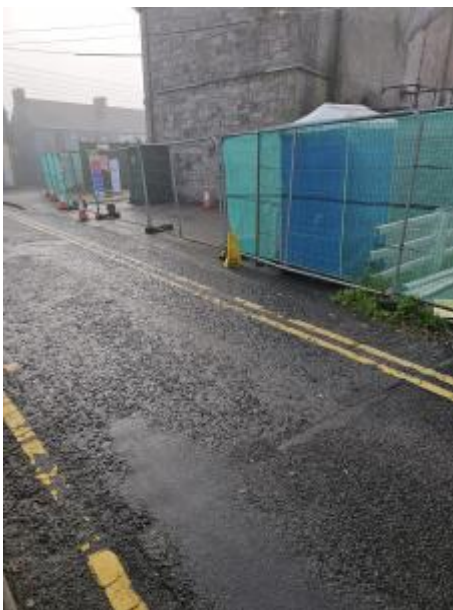
001 / 036

Parking along the gable to the Market House to be modified to allow the construction of the 6m wide access road.

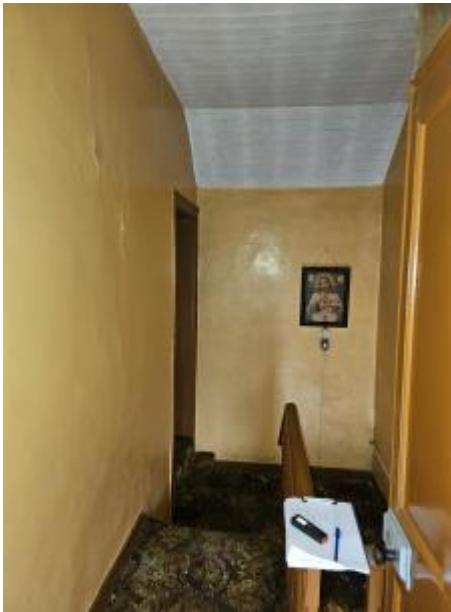
001 / 037

Upstairs landing all timber joists

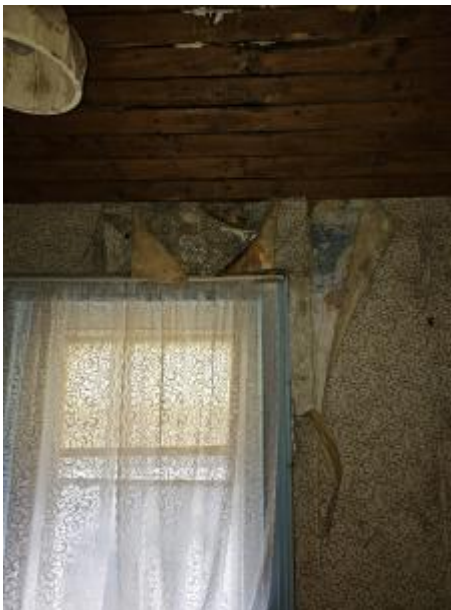
001 / 038

Upstairs front right bedroom

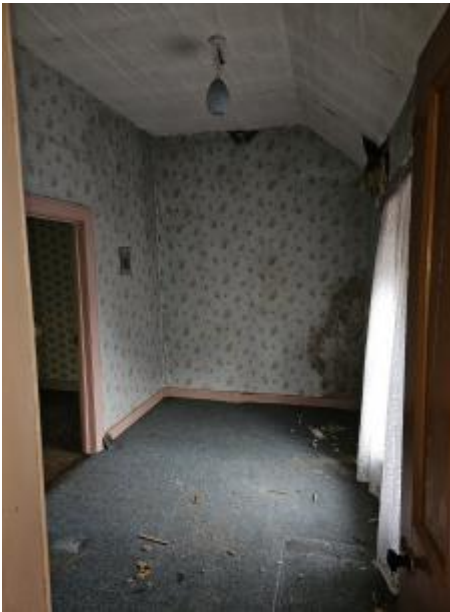
001 / 039

Upstairs front left bedroom

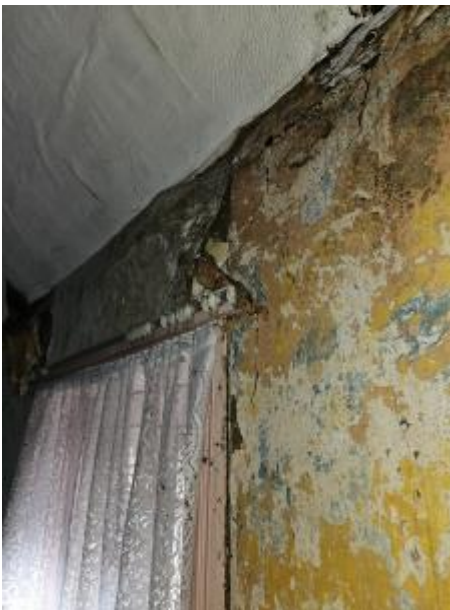
001 / 040

Rear upstairs bedroom with damp issues at eaves level

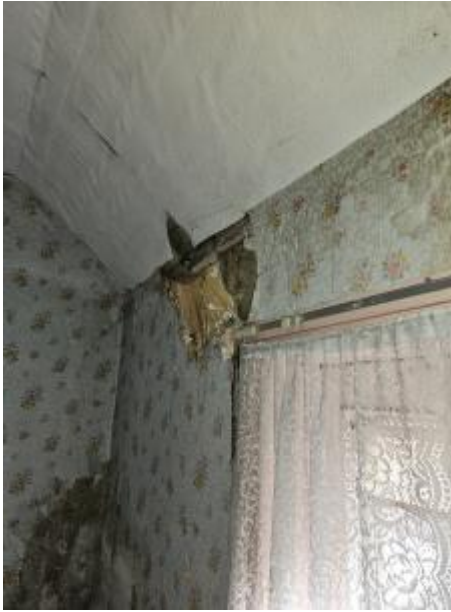
001 / 041

Upstairs front left bedroom

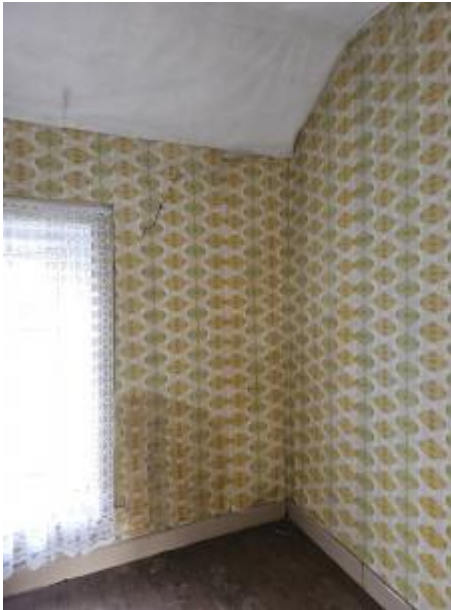
001 / 042

Upstairs front right bedroom

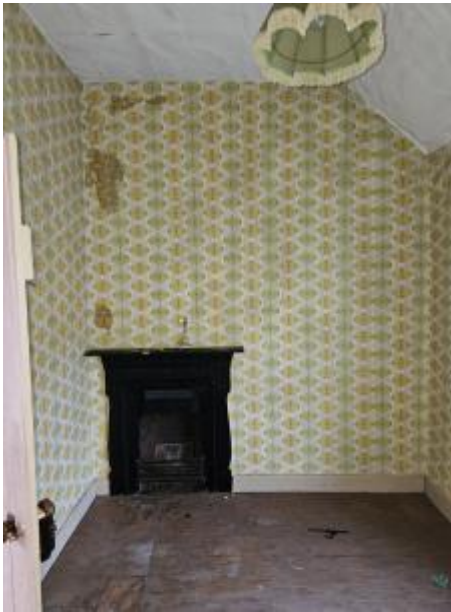
001 / 043

Upstairs bedroom of property

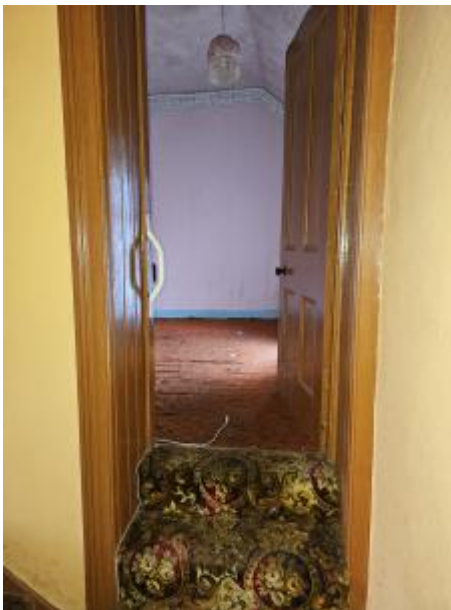
001 / 044

Upstairs rear bedroom

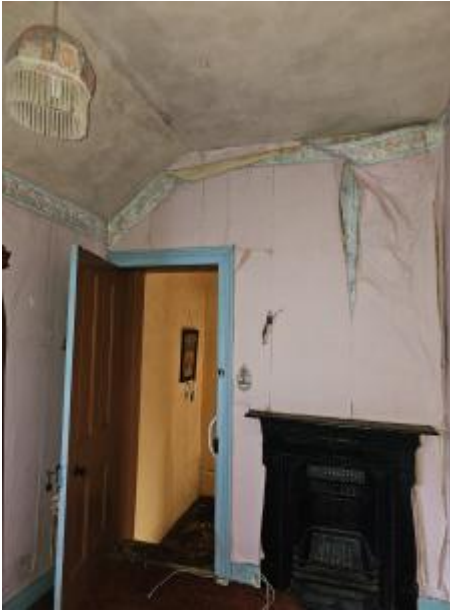
001 / 045

Upstairs rear bedroom

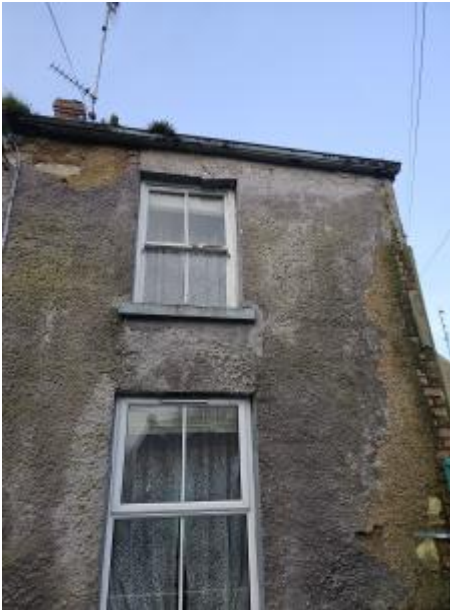
001 / 046

Front elevation of property and power cables to be disconnected prior to demolition

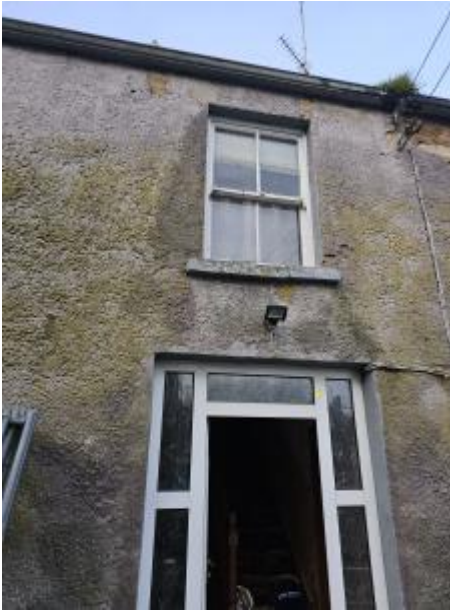
001 / 047

Front elevation of property and power cables to be disconnected prior to demolition

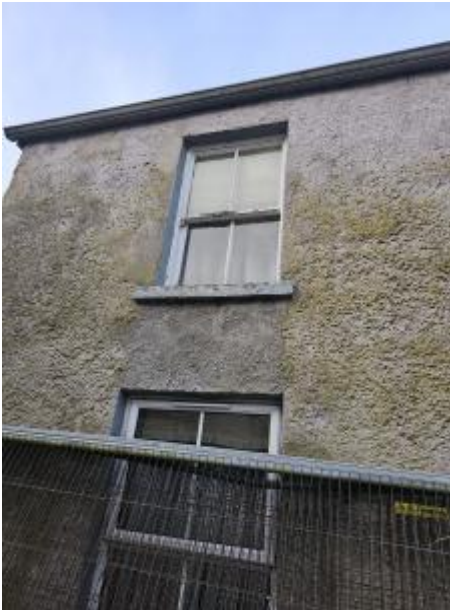
001 / 048

Front elevation of property with single glazed timber sliding sash
