Appendix 9.8

Piling Risk Assessment

**Cavan Regional Sports Campus, Cavan
County Cavan**

Issued: March 2024

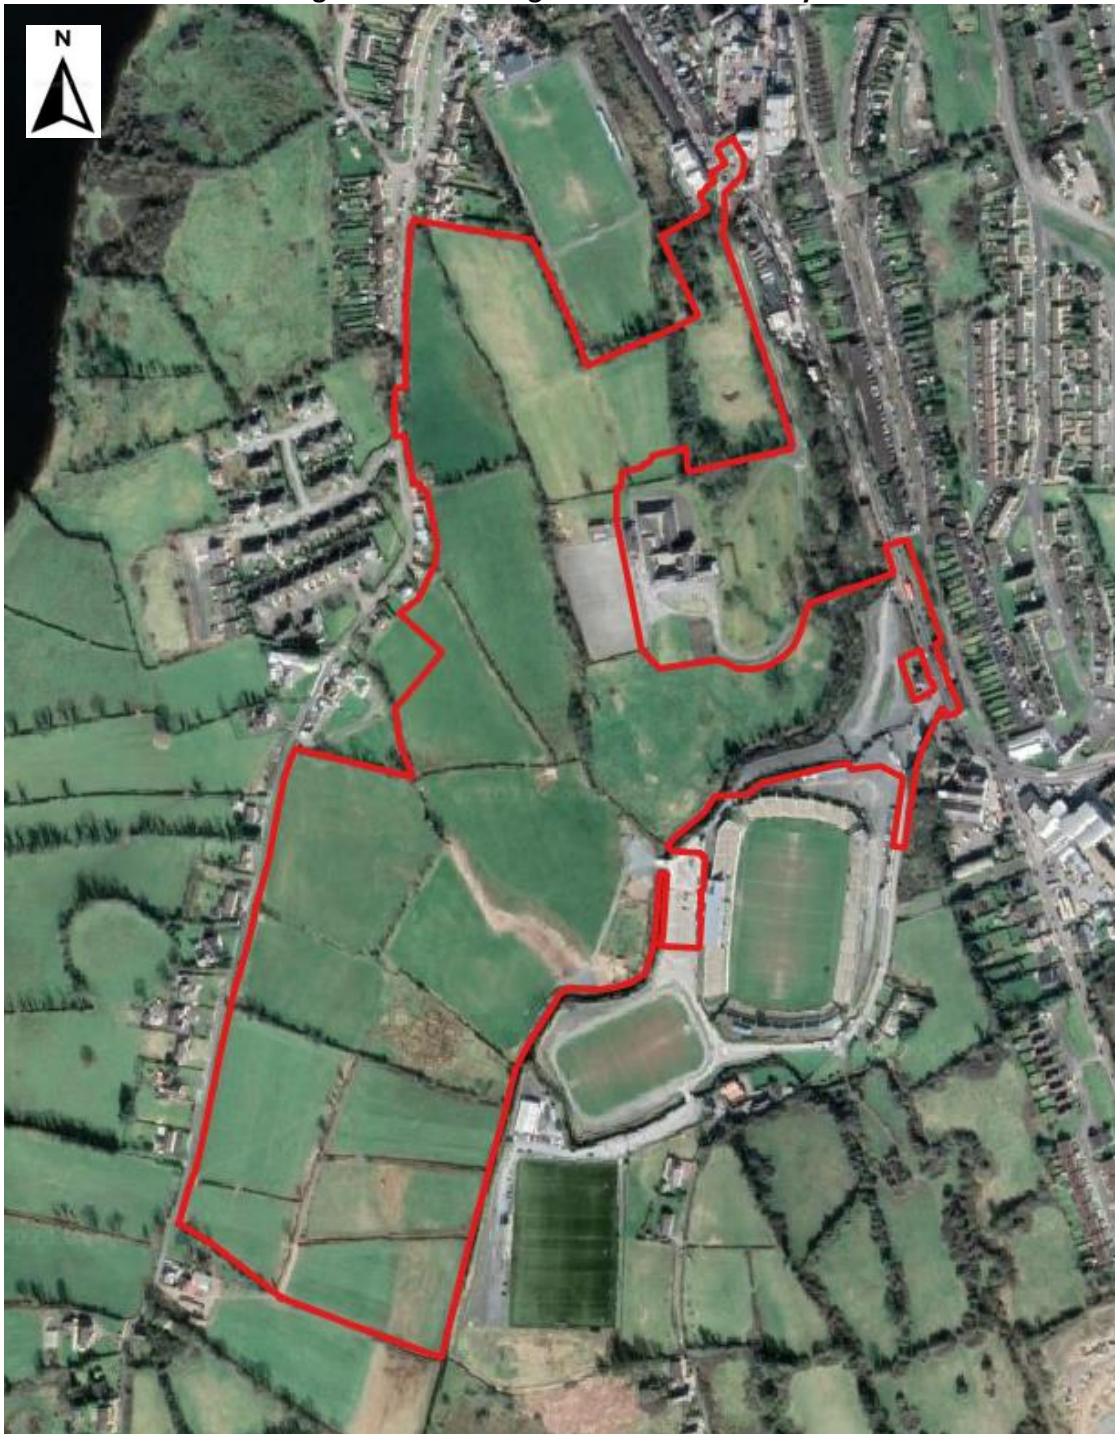
Figure 2: Aerial Image of the Site Boundary

The site, c.27.5ha, is located in central Cavan, County Cavan, on lands surrounding Royal School, College Street and west/northeast of Kingspan Breffni (IGR: 241769, 303932). A site location map is presented as Figure 1 and the site area is presented as Figure 2.
